## QAQC Report for the Automatic Urban and Rural Network, July-September 2016

Report for Defra and the Devolved Administrations  
Defra contract number 21316

Ref: ED60071201\_2016Q3- Issue 1

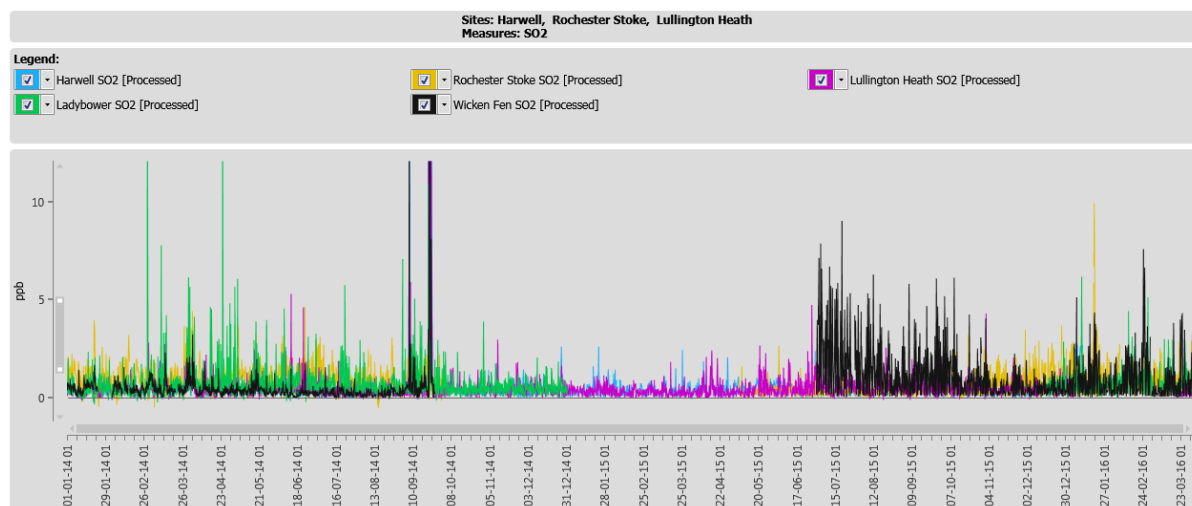
Figure 4-1 Comparison of Wicken Fen SO<sub>2</sub> with Other Rural AURN Sites, Jan 2014 - Mar 2016

However, SO<sub>2</sub> at Wicken Fen remained high, frequently much higher than measured at the other rural sites (Figure 4-1). Quarters 1 and 2 of 2015 were rejected: Q3 and Q4 of 2015 were given the benefit of the doubt as it was not possible to rule out a genuine source as the cause of the high erratic measurements.

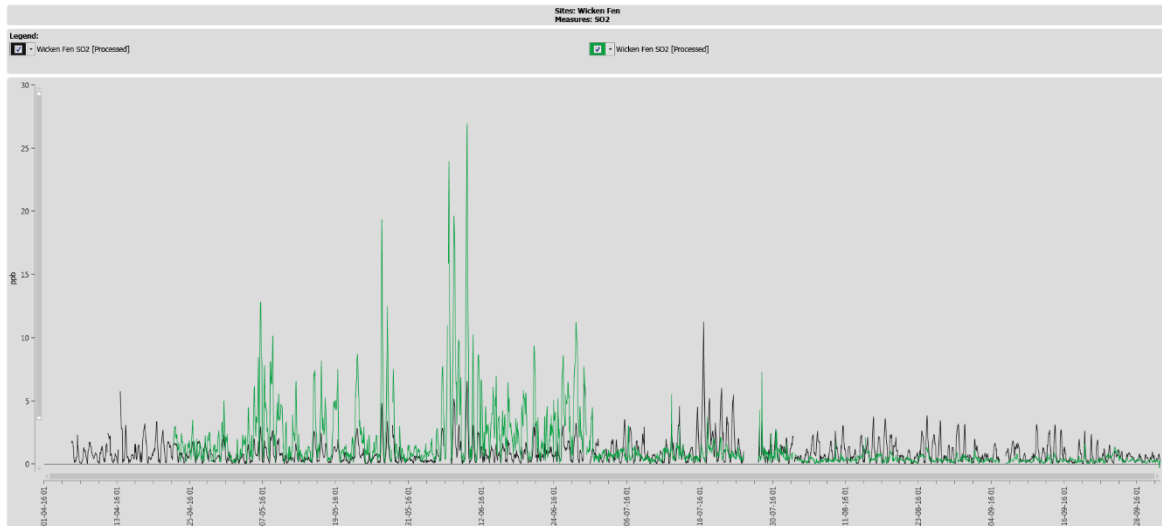
**Figure 4-2 Measurements from Original and Duplicate Analyser at Wicken Fen, Apr – Sep 2016.**

4. On 2<sup>nd</sup> Aug, after both analysers were changed so they were both sampling from the new inlet, and the loose filter holder in the duplicate instrument was tightened, the data from the duplicate analyser became lower and less spiky than that from the original analyser.
5. From this point onwards the duplicate analyser gave results consistent with other rural sites in the east of England (Figure 4-6).

1. The original SO<sub>2</sub> analyser was faulty and was recording high and noisy data regardless of the inlet used.
2. The duplicate analyser was producing even higher and more erratic data than the original, during the earlier part of the study. This is believed to have been caused by the filter holder being loose. When this was remedied on 2<sup>nd</sup> Aug 2016, the results became consistent with those from other rural sites.
3. The choice of inlet used made no difference to either analyser's dataset.

1. The duplicate analyser should be left in place, sampling through the new inlet. This should replace the original analyser which is faulty and should be repaired, or disposed of if beyond economic repair.
2. The remaining data from the original analyser, from Q3 and Q4 of 2015, and 2016, should be rejected.
3. The data from the duplicate analyser, from the start of the study on 22<sup>nd</sup> Apr to the point when the filter holder was tightened, should also be rejected. The data from this point onwards are valid.
4. The study highlights the importance of the filter holder being properly tightened as if this is loose it can cause noisy data.
5. Previously, inlet ports have been reported as being loose, more than once, on the original analyser. This should also be checked regularly.
